Mabbett & Associates, Inc.
Environmental Consultants & Engineers

Subject: Limited Asbestos and Lead Inspection
Bedford VA Medical Center, Building 22, Boiler Plant
Mabbett Project No. 2011012.001

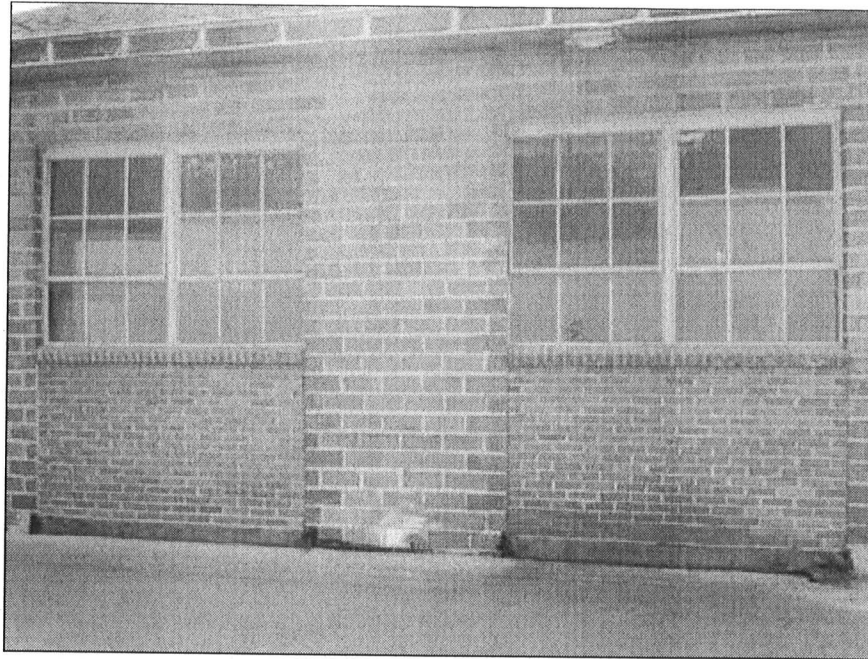
Material Description	Location	Estimated Quantity
Black Waterproofing	Below Two (2) Windows at Roadway Level	20 Linear Feet
Old Window Caulking	Perimeter of Two (2) Windows	60 Linear Feet
Window Glazing	Interior of Two (2) Windows	224 Linear Feet

Black Waterproofing

ACM in the form of black waterproofing and window caulking and glazing was identified in the surveyed areas expected to be impacted by the project. ACM that will be disturbed during renovations must be removed in advance by a properly licensed abatement company and in accordance with EPA, state, and local regulations. Project specifications for removal/abatement of ACM should be prepared by a Massachusetts licensed asbestos Project Designer. The abatement procedures are detailed in 310 CMR 7.15(c) Procedures for Asbestos Emission Control. Procedures include but are not limited to creating a regulated area, putting in place barriers, wet removal of material, final cleaning, and disposal of asbestos waste at approved landfill. The procedures should also be consistent with VA directives and specifications.

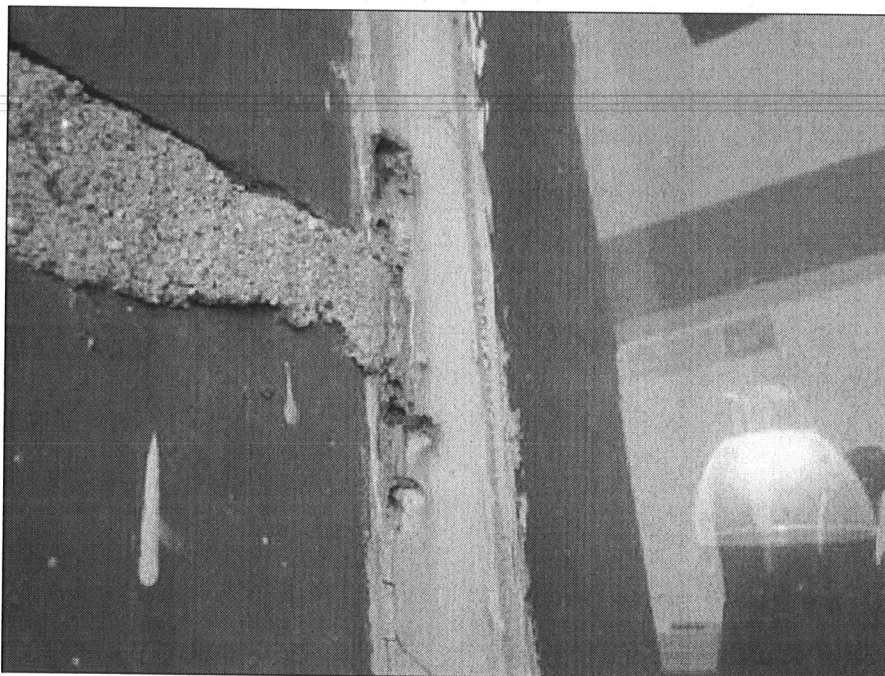
Old Window Caulking

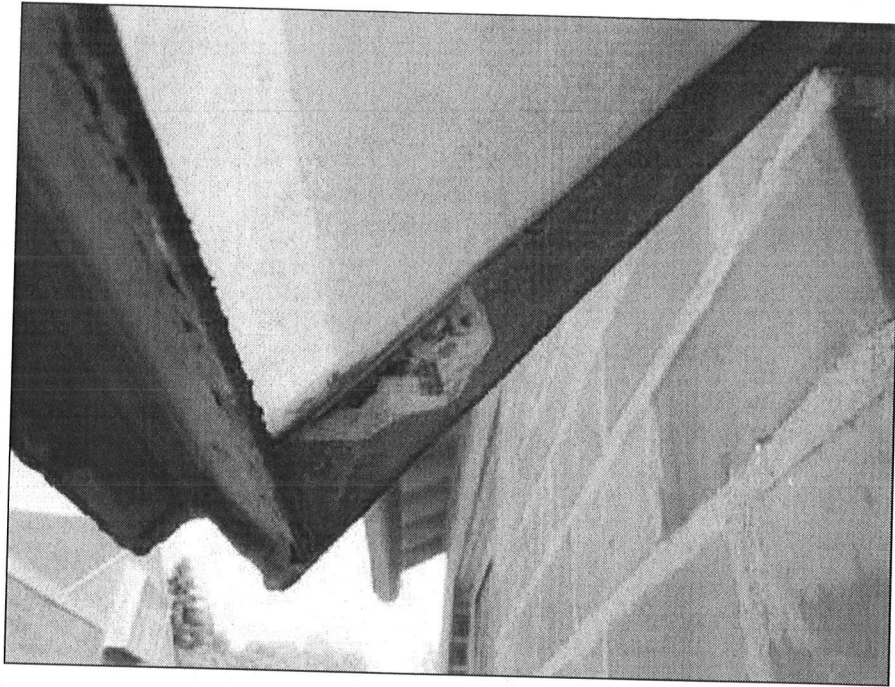
Window Glazing
